Manhole Inspection Summary

Manhole # S21G1_006MH

Insp Date: **4/29/08 2:18 PM**

Location Address: **2513 banger st**

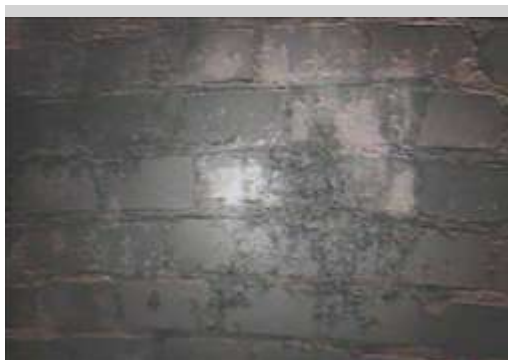
Defect 4

Infiltration: ☐ None ☐ Joint ☐ Cracks ☐ Mortar ☐ Roots ☒ **Wall**

infiltration @ barrel wall

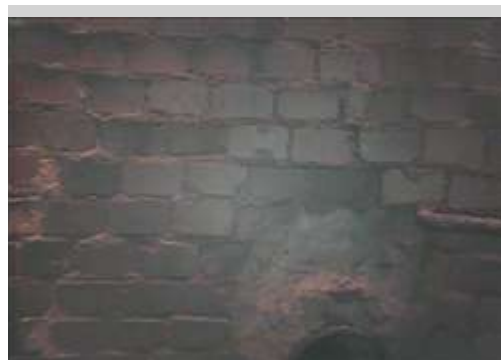
Defect 3

Condition: ☐ Sound ☐ Cracked ☐ Root Intrusion ☐ Loose Brick ☒ **Deteriorated**

deteriorated barrel bricks; bricks missing from above service @ 3 oclock

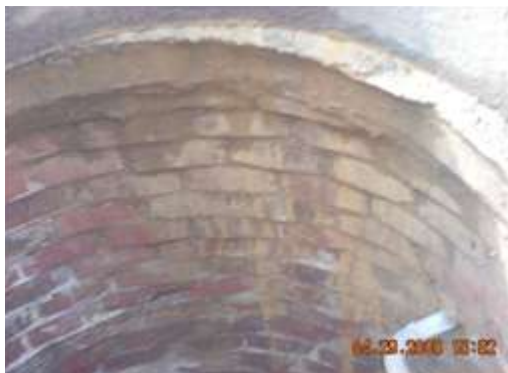
Defect 2

Infiltration: ☐ None ☒ **Joint** ☐ Cracks ☐ Mortar ☐ Roots ☐ Wall

infiltration @ chimney/frame joint

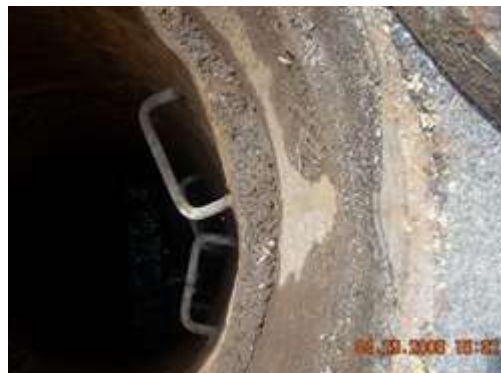
Defect 1

Offset: **1** (in.)

frame offset

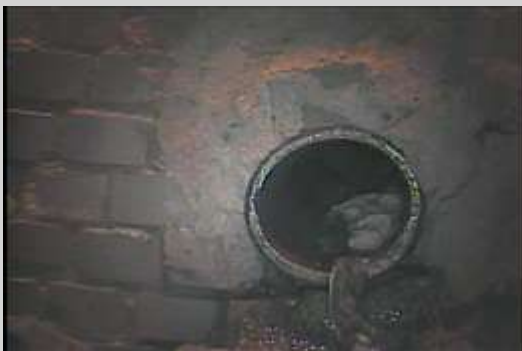
3 O'Clock Inflow

Pipe Height: **6** (in.) Rod and Bar (Angled)
Pipe Material: **Clay** ☐ Pipe Lined
Invert Depth: **12.40** (ft.) Flow Characteristics: **Slow**
Deposits: ☐ None ☐ Mud ☒ **Sludge** ☐ Debris ☐ Grease
Silt Depth: **2** (in.) Deposits Extent: **Medium**
Infiltration: **None** Pipe Seal Cond: **Broken**
